Manhole Inspection Summary

Manhole # S47MM_047MH

Insp Date: **5/7/08 8:21 AM**

Location Address: **Patterson Park Ave**

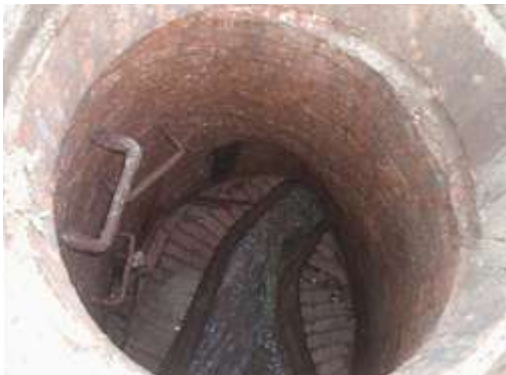
Defect 2

Frame Offset: **1** (in.) Condition: ☐ Sound ☐ Cracked ☒ **Leaks**

Frame leaks

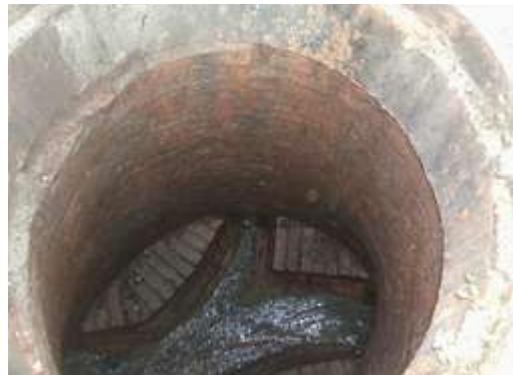
Defect 1

Infiltration: ☐ None ☐ Joint ☐ Cracks ☐ Mortar ☐ Roots ☒ **Wall**

Infiltration

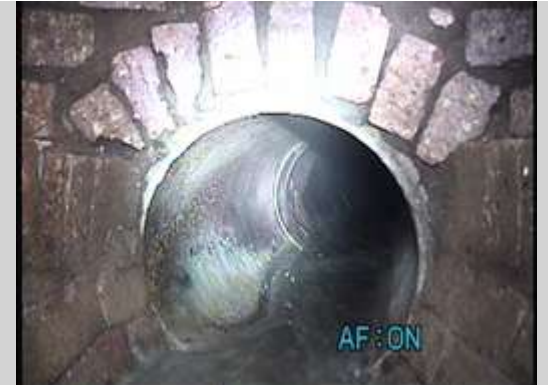
12 O'Clock Outflow

12 in. Circular Gravity Sewer
Pipe Out @ 12 O'Clock

Pipe Height: **12** (in.) Rod and Bar (Angled)
Pipe Material: **Clay** ☐ Pipe Lined
Invert Depth: **8.50** (ft.) Flow Characteristics: **Fast**
Deposits: ☒ None ☐ Mud ☐ Sludge ☐ Debris ☐ Grease
Silt Depth: (in.) Deposits Extent:
Infiltration: **None** Pipe Seal Cond: **Sound**

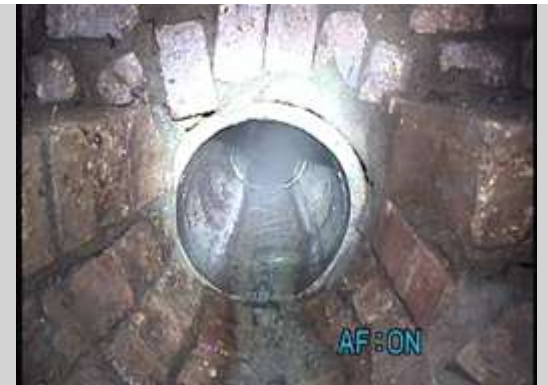
3 O'Clock Inflow

8 in. Circular Gravity Sewer
Pipe In @ 3 O'Clock

Pipe Height: **8.4** (in.) Rod and Bar (Angled)
Pipe Material: **Clay** ☐ Pipe Lined
Invert Depth: **8.15** (ft.) Flow Characteristics: **Fast**
Deposits: ☒ None ☐ Mud ☐ Sludge ☐ Debris ☐ Grease
Silt Depth: (in.) Deposits Extent:
Infiltration: **None** Pipe Seal Cond: **Sound**

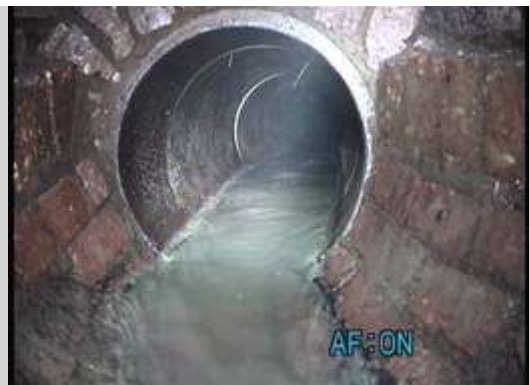
6 O'Clock Inflow

12 in. Circular Gravity Sewer
Pipe In @ 6 O'Clock

Pipe Height: **12** (in.) Rod and Bar (Angled)

Infiltration: **None** Pipe Seal Cond: **Sound**
